The 4150 Fund 2023 Newsletter CBS No. 8179

Engineering Report - Tony Howard

Fitting the boiler back in the frames.

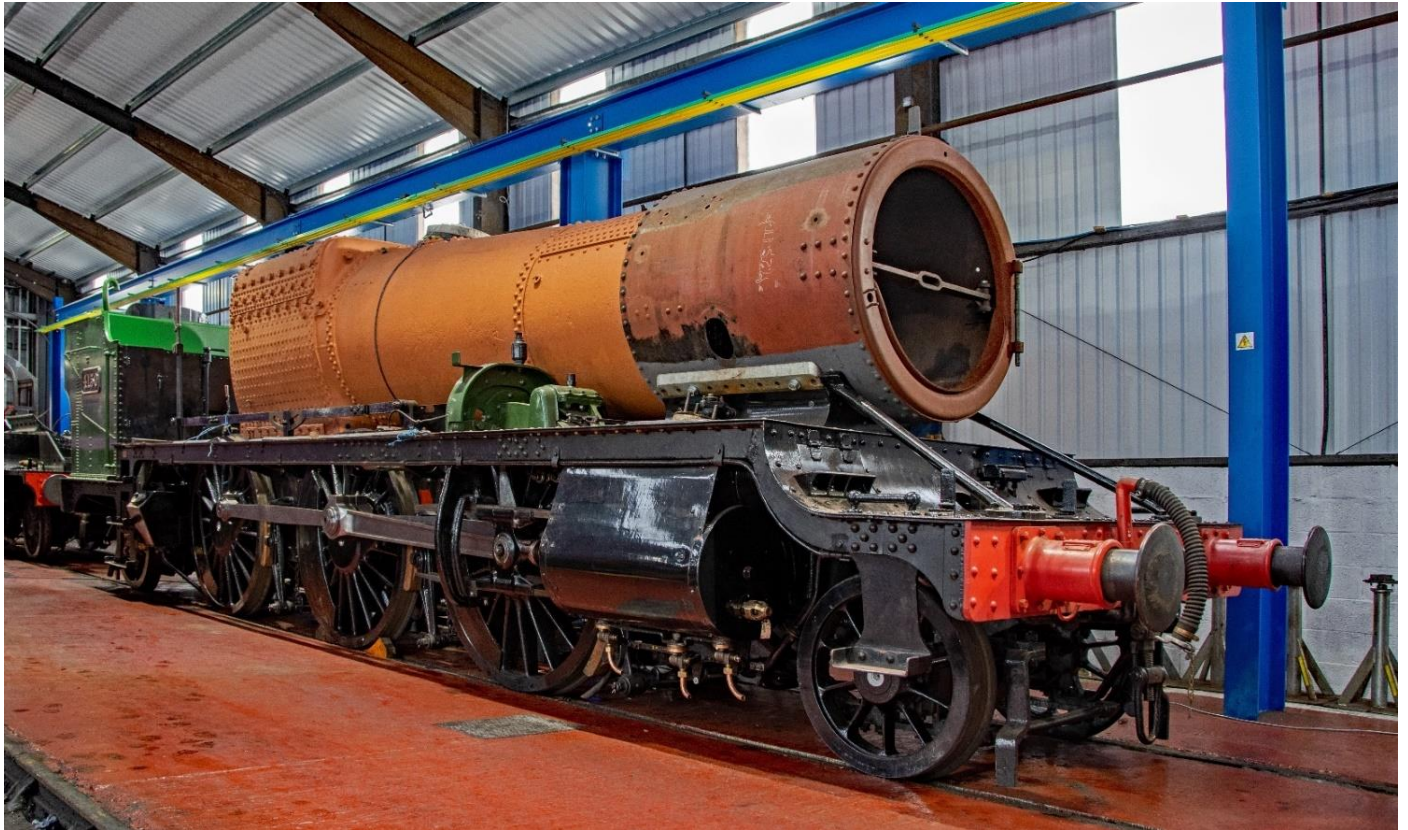
4150 looking like a real loco again with the boiler trial fitted to enable pipework to be formed.

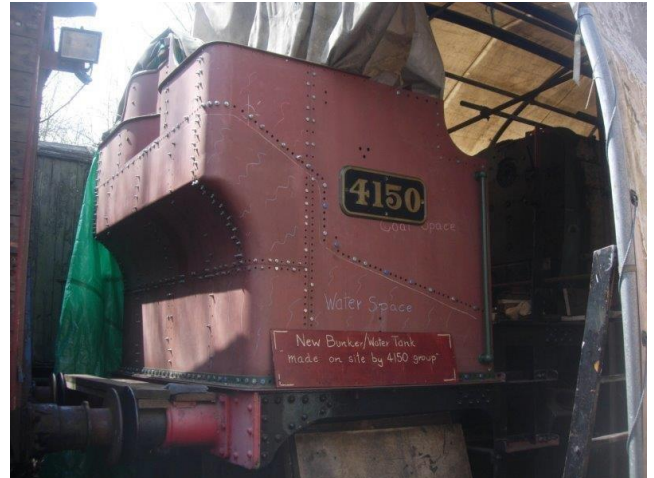
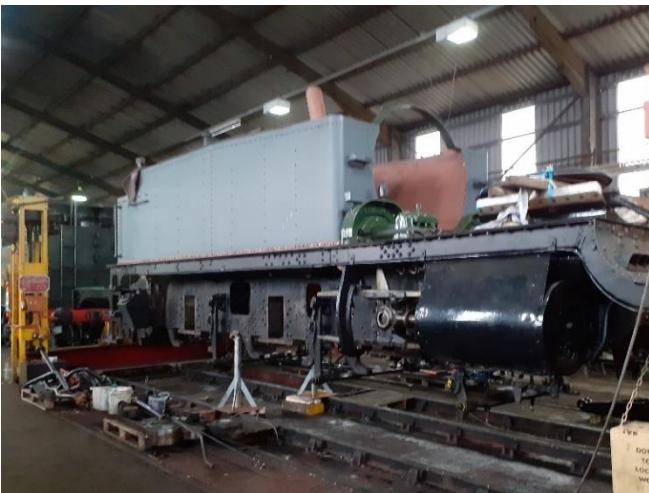
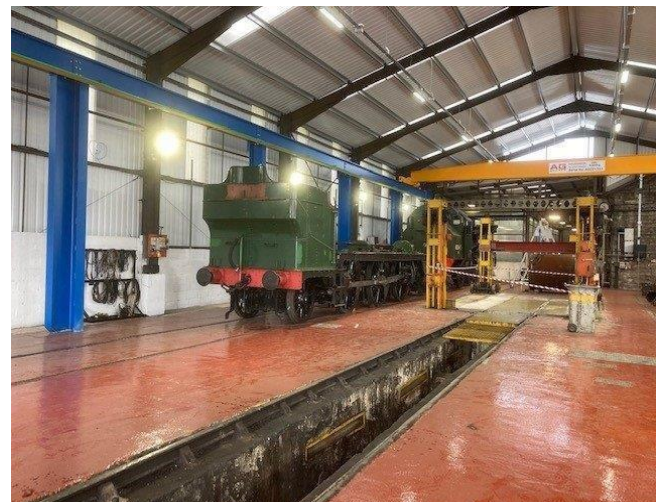
By 2009 restoration work was well under way on the chassis and related fittings along with plans for new side tanks and bunker. Working conditions were far from ideal for the growing band of dedicated working volunteers with little protection from the elements and using only basic tools.

2018 sees the boiler being readied for its journey to Bridgnorth and it was lifted from the frames in Bewdley yard in July. Work started on it within an hour of its arrival at the boiler shop and continued at a pace. It is now very near completion and is a model of collaboration between volunteers and full time SVR staff.

In April 2021 the engine finally took its place in the workshop at Bridgnorth and was lifted clear of the wheels giving good access to the underside. The engine is now back on its wheels and the boiler trial fitted so the pipework can be formed. Despite Covid and being almost forgotten in a Bewdley siding we are finally getting there.

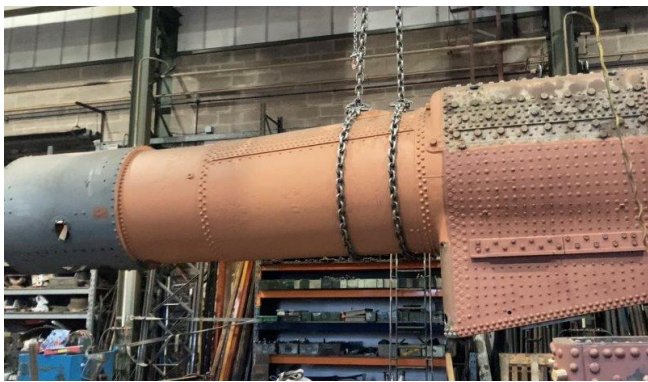
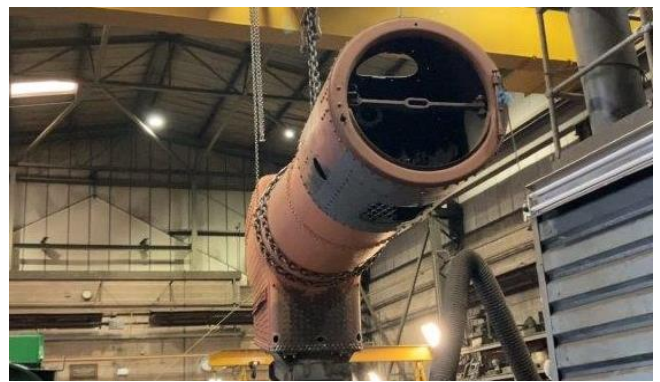
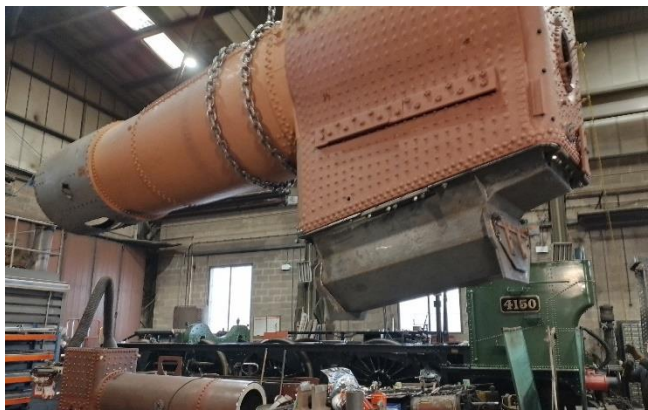
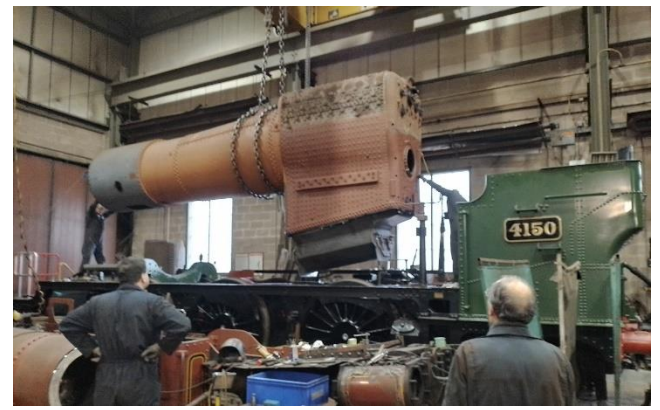
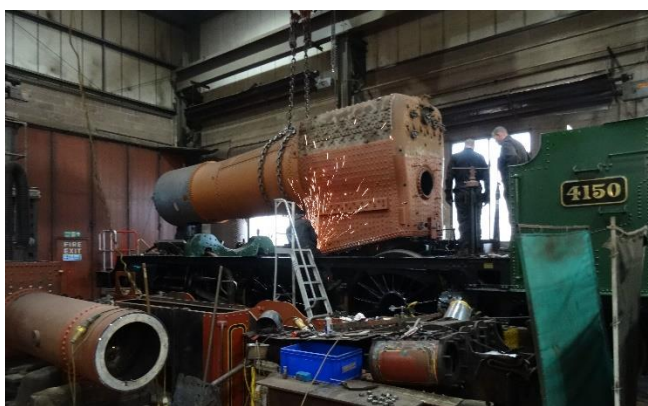
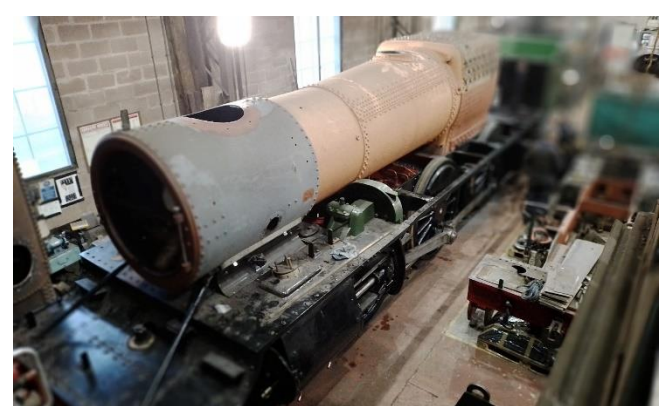
4150 has a Standard Number 2 boiler originally designed to operate at 200psi but for class 61XX it was uprated to operate at 225psi., to save weight nickel was added to the steel. Our engine will operate at 200psi. When empty the boiler weighs approximately 15 tons, the firebox grate is 7ft. long and the barrel length is 10ft. 3 inches.

Below are photographs taken by our working volunteers starting with the initial well-balanced lift and then picking up the new ashpan which is more visible in the third photograph. Next the precarious job of merging it with the frames, so tight was the fit the heads of the foundation ring rivets were ground back and will need attention when the boiler is next lifted for testing. The last photograph shows a job well done.

The loco was shunted round into the boiler shop ready to reunite the boiler to the loco on 29th December. This operation took nearly all day, but the boiler was sitting in the frames and bolted in securely.

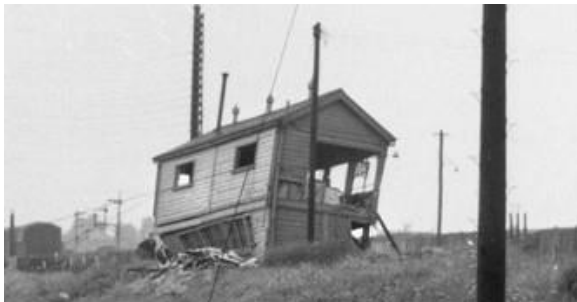
Rear view of damaged box

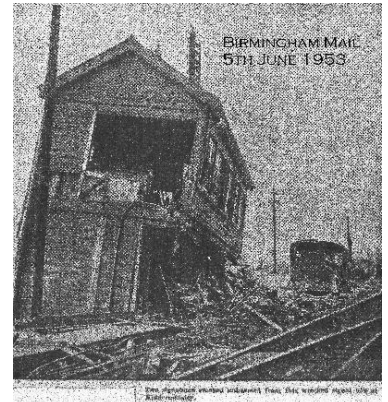
Shortly after 10 pm a wagon near the head of an Oxley to Tavistock Junction fast fitted freight had derailed and tilting sideways ripped out the lower front structure of the Signal Box. The badly damaged remains of the Box, of timber construction, tipped down and sideways to rest against a stout telegraph pole. The wagon chassis landed upside down on the embankment having shed its body and contents just beyond the Box leaving debris scattered across the track.

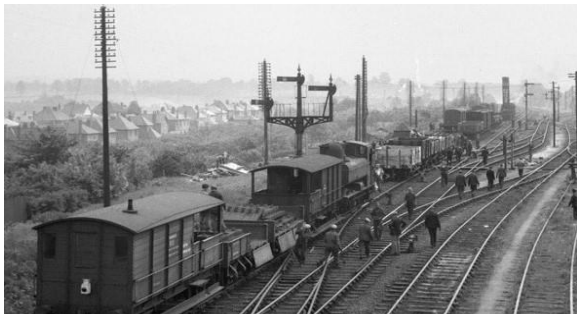
Repairs and clearance underway

Much trackwork and S & T installations required replacement or repair and were carried out using engineering trains and personnel from Worcester Depot. Construction of a permanent replacement Signal Box was not completed until October 1953 and was of a non-standard modern flat roofed design. This subsequently closed in August 2012 and demolished shortly after when all train control was transferred to West Midlands Signalling Centre at Saltley, Birmingham. The 63-lever frame was however saved by the SVR for possible future re-use.

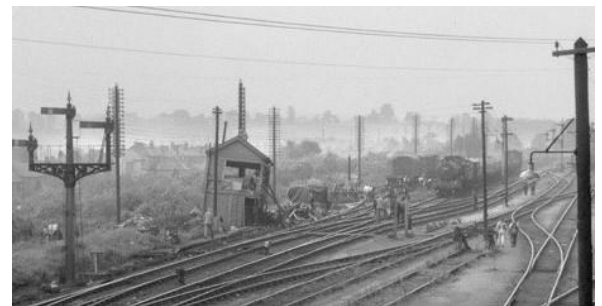
General view of damage, Down freight approaching

Although the Box was put out of use the immediate priority was to clear the debris from the adjacent lines and maintain traffic flow using the Down main and goods lines. Surprisingly little disruption other than delayed services resulted. The Box was initially shored up to prevent total collapse but subsequently demolished and replaced by a temporary structure.
